RESOLUTION NO. 2017- 35

A RESOLUTION OF THE BOARD OF COUNTY COMMISSIONERS OF ST. JOHNS COUNTY, FLORIDA, GRANTING AN AD VALOREM TAX EXEMPTION FOR IMPROVEMENTS TO HISTORIC PROPERTY LOCATED AT 34 CORDOVA STREET, ST. AUGUSTINE, FLORIDA, IN ACCORDANCE WITH ST. JOHNS COUNTY ORDINANCE 97-61 AND SECTION 196.1997, FLORIDA STATUTES, AND PROVIDING AN EFFECTIVE DATE.

HISTORIC ARCHITECTURAL REVIEW BOARD
STAFF REPORT AND RECOMMENDATION

Certificate of Appropriateness and Certification of Completion for ad valorem tax exemption F2014-0145

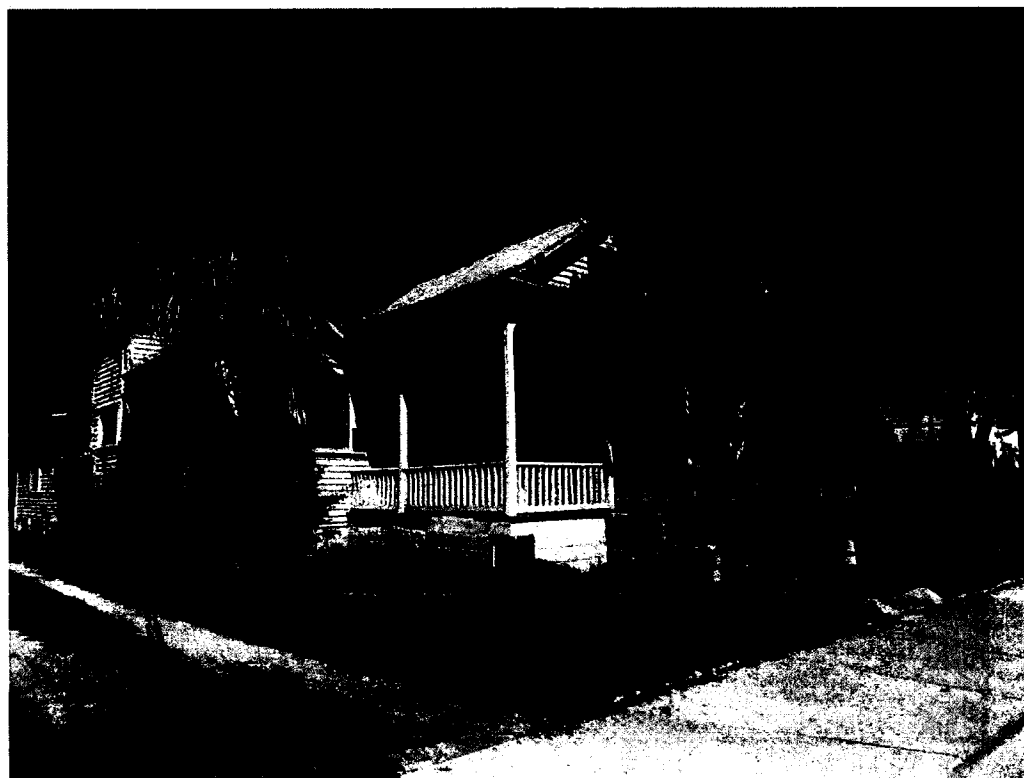
34 Cordova Street
Tax Exemption – Amendment
Photos at time of Property Acquisition
East (Front) Façade – View SW
and View NW
