RESOLUTION NO. 2023 -372

A RESOLUTION BY THE BOARD OF COUNTY COMMISSIONERS OF ST. JOHNS COUNTY, FLORIDA, AUTHORIZING THE COUNTY ADMINISTRATOR, OR DESIGNEE, TO PIGGYBACK THE FLORIDA SHERIFF'S CONTRACT (FSA22-VEH20.0), TO EXECUTE AND ISSUE A PURCHASE ORDER FOR FOUR (4) CUTAWAY BUSES FOR THE COUNTY'S TRANSITY SYSTEM, FOR A TOTAL PURCHASE PRICE OF \$575,818.00.

## FSA Item 15 2023 Starcraft Allstar 22'

**STARCRAFT BUS  
MODEL ALLSTAR XL**

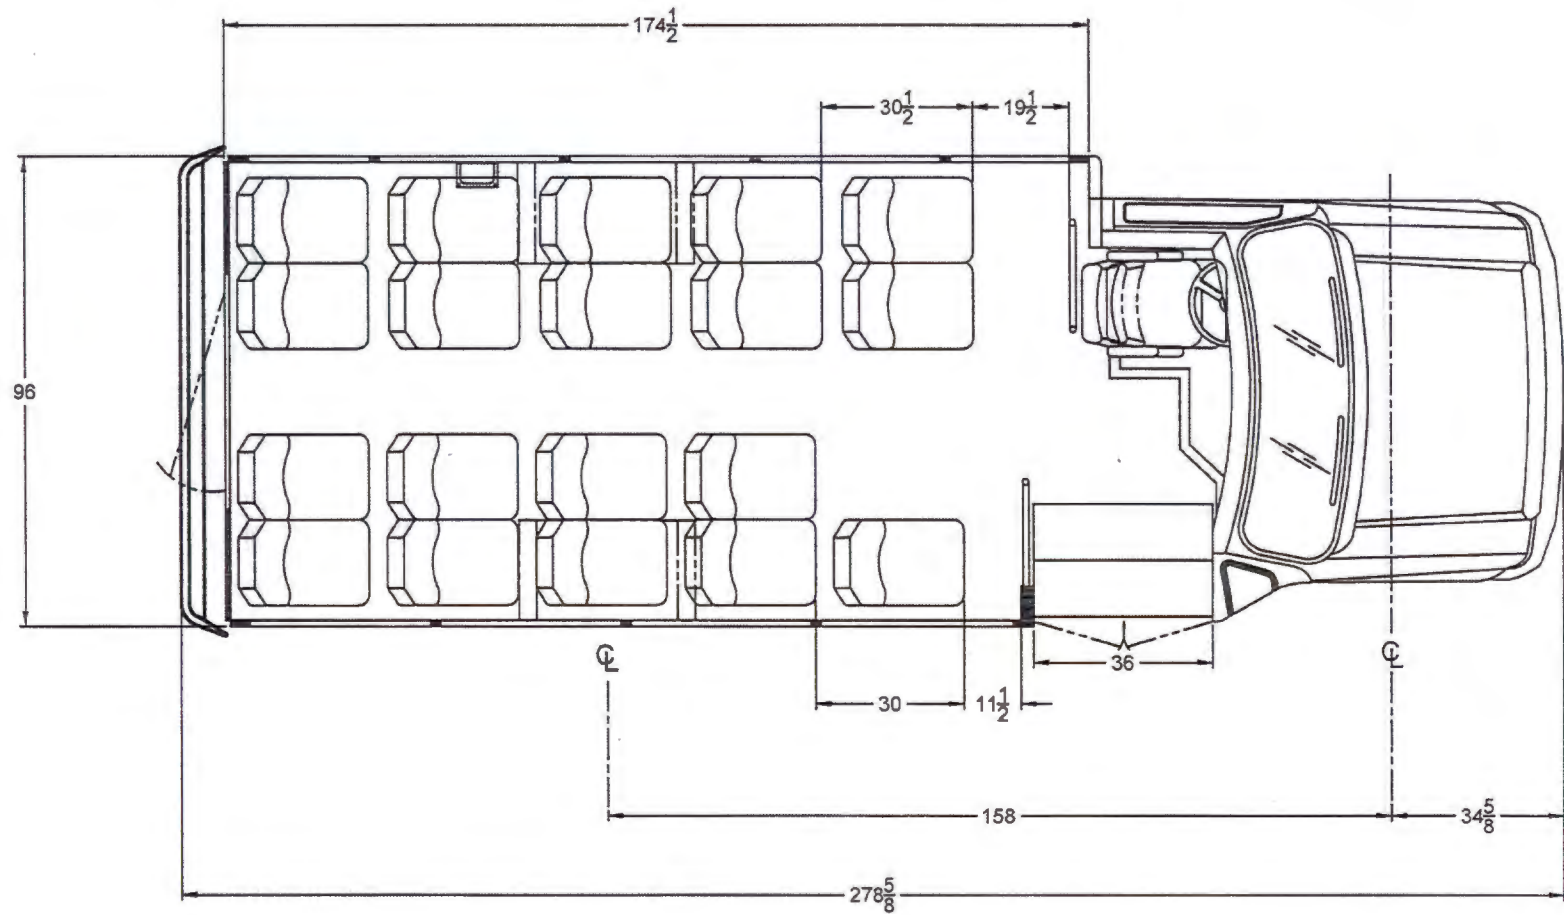
TITLE: 19 PASS, 158" WB MODEL 22  
 NAME: CRANS DATE: 8/24/22  
 DWG. No. 19 PASS 158 163 FRB

NOTE: SHOWN WITH MID HI FREEDMAN SEATS  
 E-350 12,500 GVWR  
 THIS FLOOR PLAN IS FOR ILLUSTRATION PURPOSES ONLY.  
 A WEIGHT ANALYSIS HAS NOT YET BEEN PERFORMED.  
 FINAL APPROVAL WITH A WEIGHT ANALYSIS IS REQUIRED UPON RECEIPT OF A  
 COMPLETED ORDER WITH ALL OPTIONS SHOWN.  
 OPTIONAL EQUIPMENT MAY BE SHOWN.  
 THE SALES ORDER PLACED DICTATES ACTUAL OPTION CONTENT.

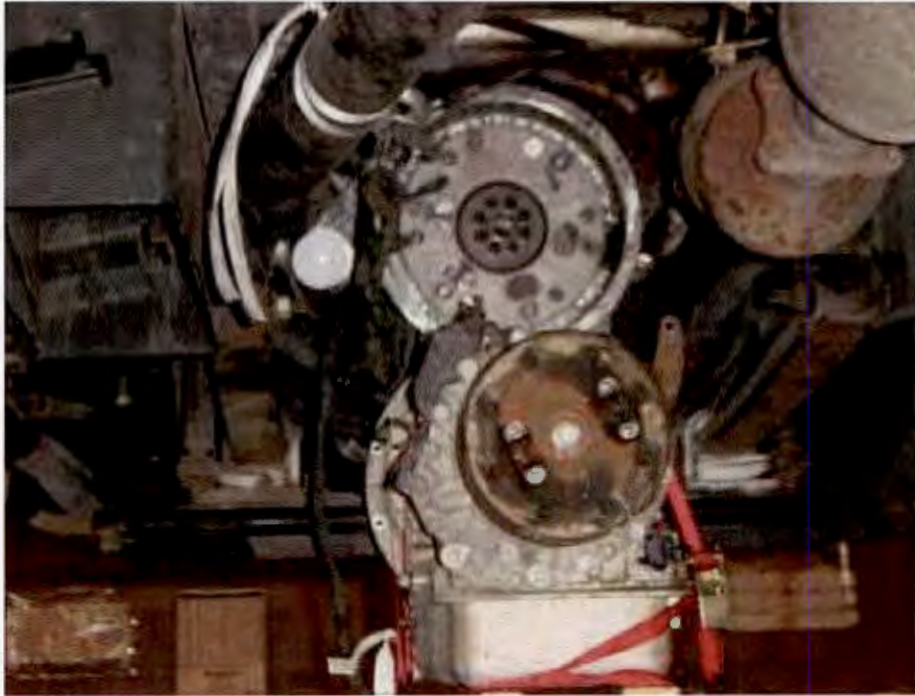
**TRANSMISSION REMOVAL AND REPLACEMENT  
(8.0 MAN HOURS)**

At the end of the test, the remaining items on the list were removed and replaced. The transmission assembly took 8.00 man-hours (two men 4.00 hrs) to remove and replace. The time required for repair/replacement of the four remaining components is given on the following Repair and/or Replacement Form.

<b>Subsystem</b>	<b>Replacement Time</b>
Transmission	8.00 man hours
Wiper Motor	0.50 man hours
Starter	0.50 man hours
Alternator	0.75 man hours
Batteries	0.25 man hours

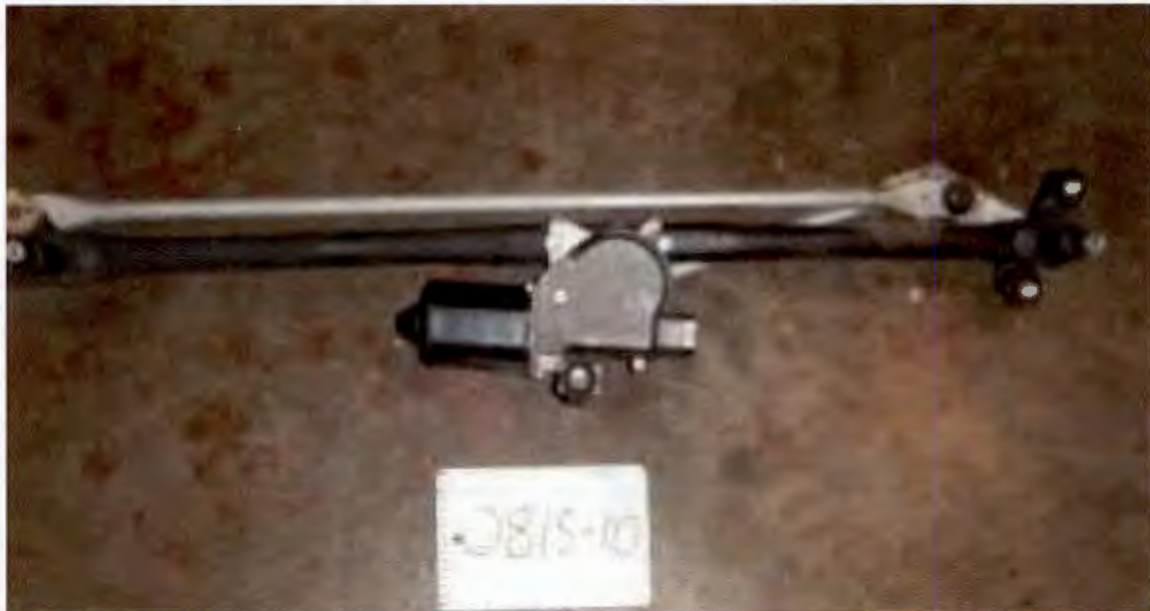
**WIPER MOTOR REMOVAL AND REPLACEMENT  
(0.5 MAN HOURS)**

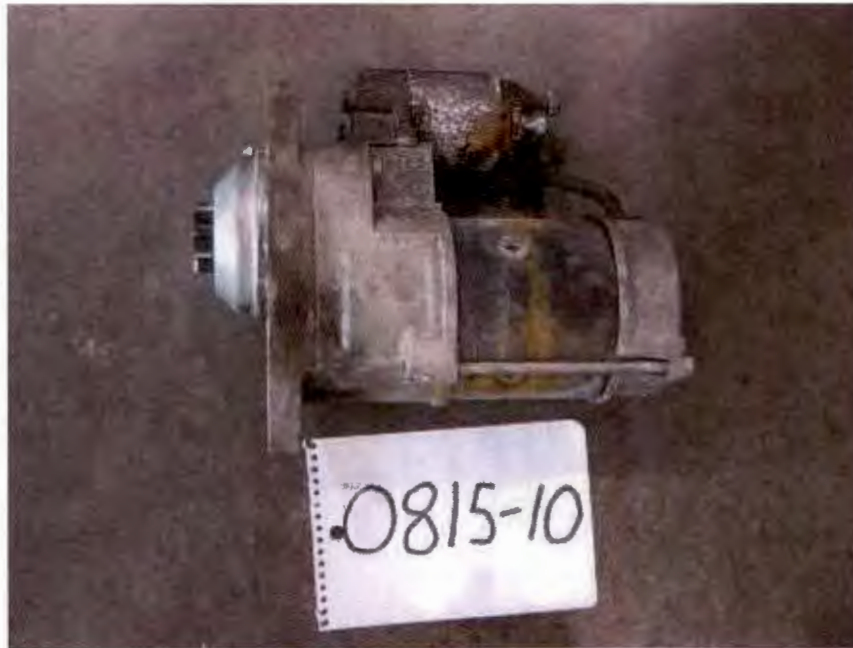
**STARTER REMOVAL AND REPLACEMENT  
(0.5 MAN HOURS)**

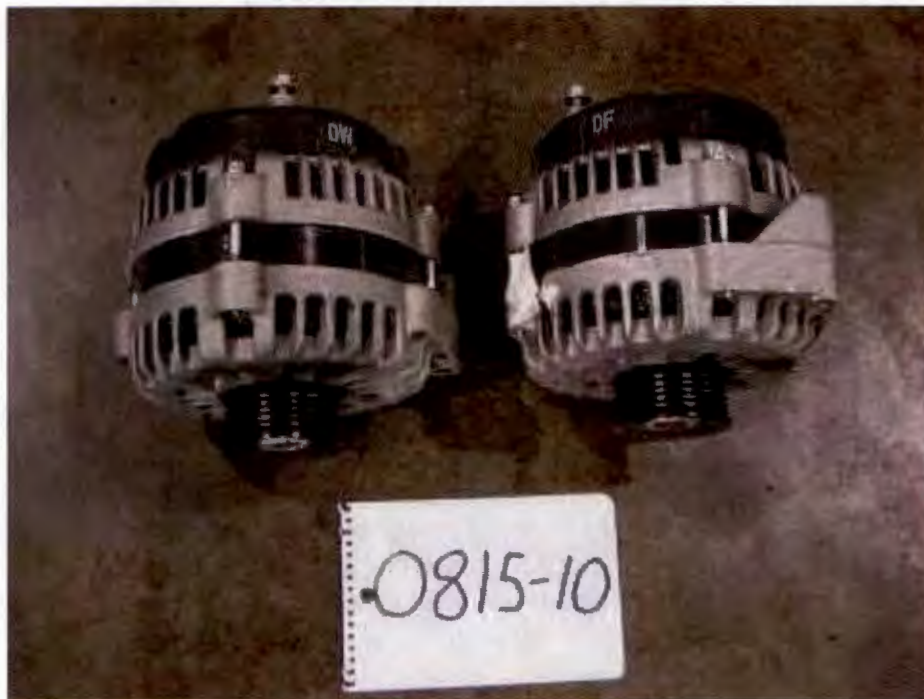
**ALTERNATORS (2) REMOVAL AND REPLACEMENT  
(0.75 MAN HOURS)**

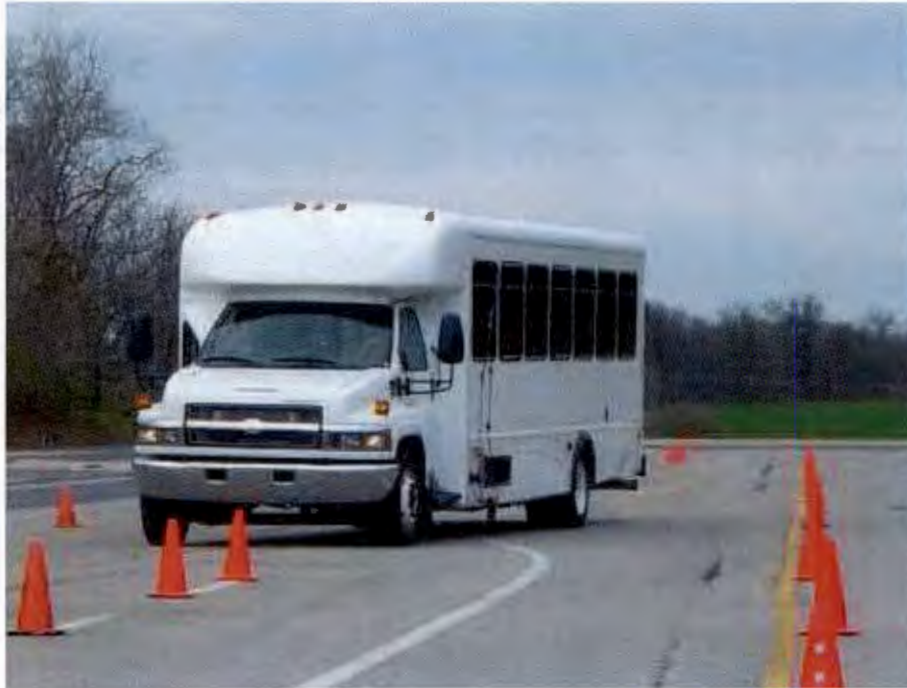
**RIGHT - HAND APPROACH**

<b>SAFETY TEST: DOUBLE LANE CHANGE</b>	
Maximum safe speed tested for double-lane change to left	45 mph
Maximum safe speed tested for double-lane change to right	45 mph
<b>Comments of the position of the bus during the lane change:</b> A safe profile was maintained through all portions of testing.	
<b>Comments of the tire/ground contact patch:</b> Tire/ground contact was maintained through all portions of testing.

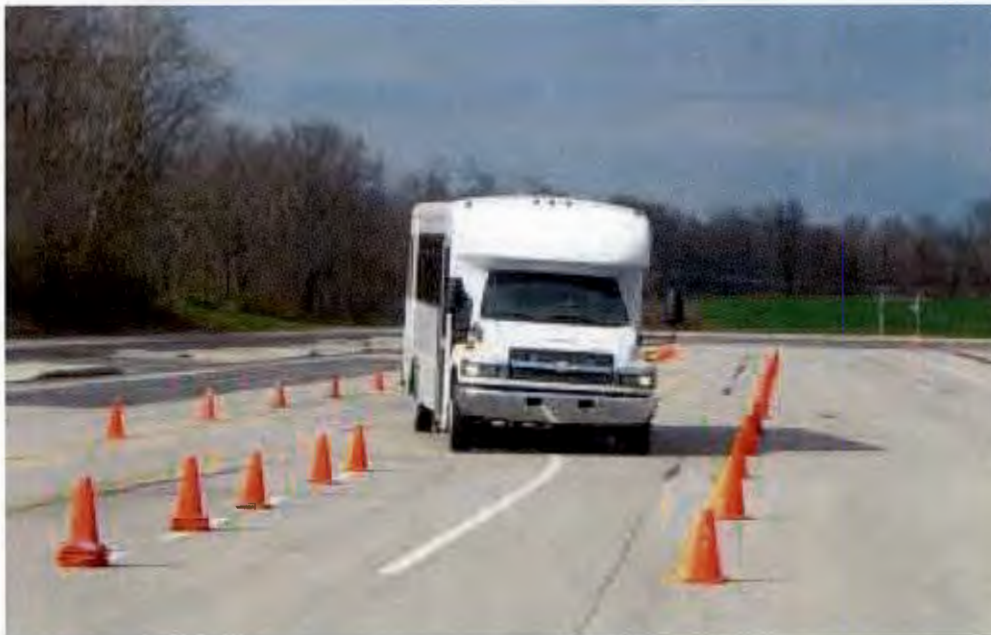
**LEFT - HAND APPROACH**

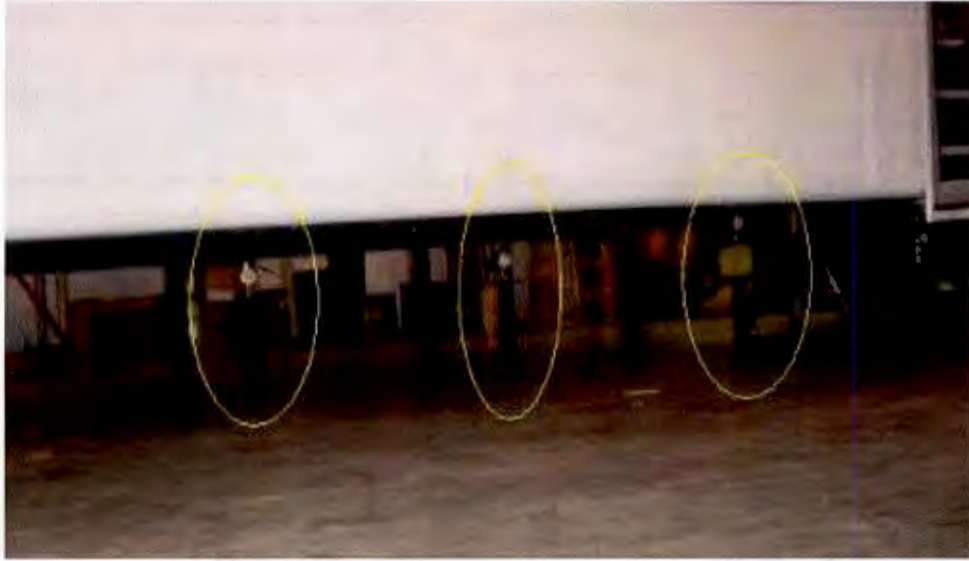
**DIAL INDICATORS IN POSITION**

The Shakedown Test produced a maximum final loaded deflection of 0.329 inches with a permanent set ranging between -0.005 to 0.007 inches under a distributed static load of 18,750 lbs. The Distortion Test was completed with all subsystems, doors and escape mechanisms operating properly. No water leakage was observed throughout the test. All subsystems operated properly.

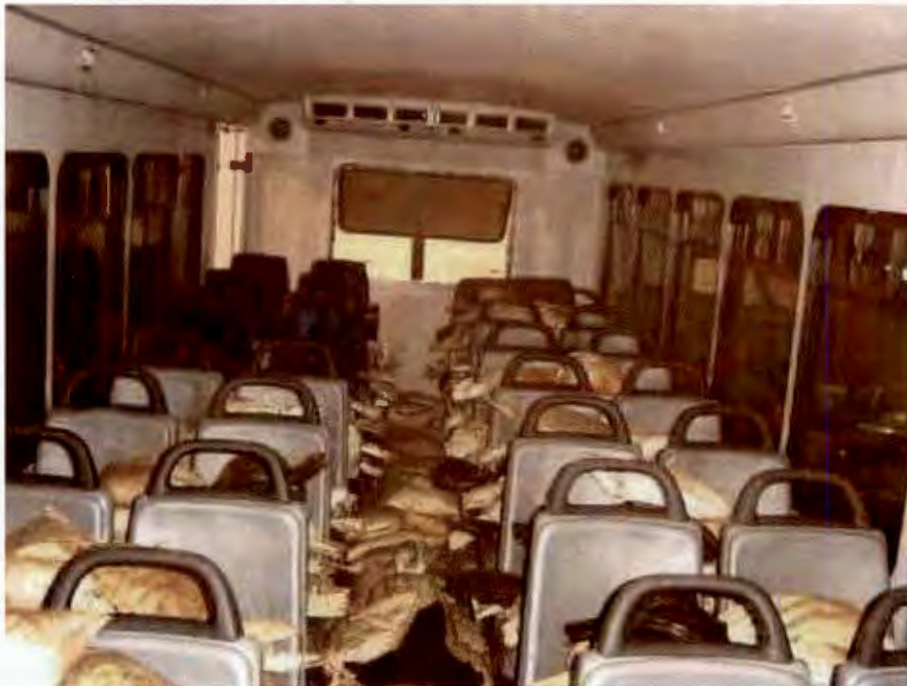
**BUS LOADED TO 2.5 TIMES GVL  
(18,750 LBS)**

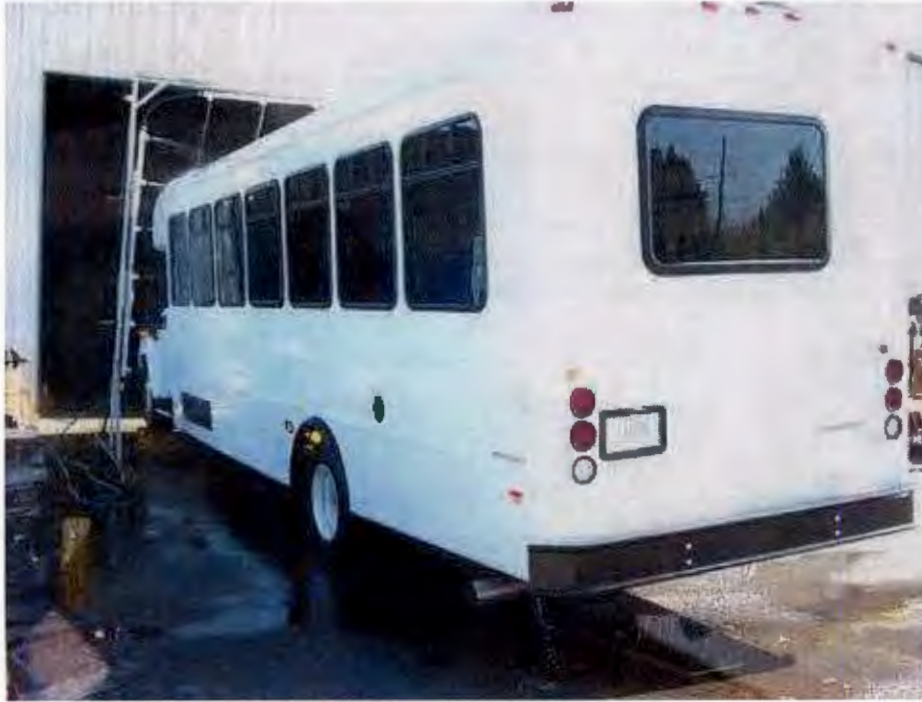
**LEFT REAR FRONT WHEEL SIX INCHES HIGHER**

All doors, windows, escape mechanisms, engine, steering and handicapped devices operated normally throughout the test. The undercarriage and body indicated no deficiencies. No water leakage was observed during the test. The results of this test are indicated on the following data forms.

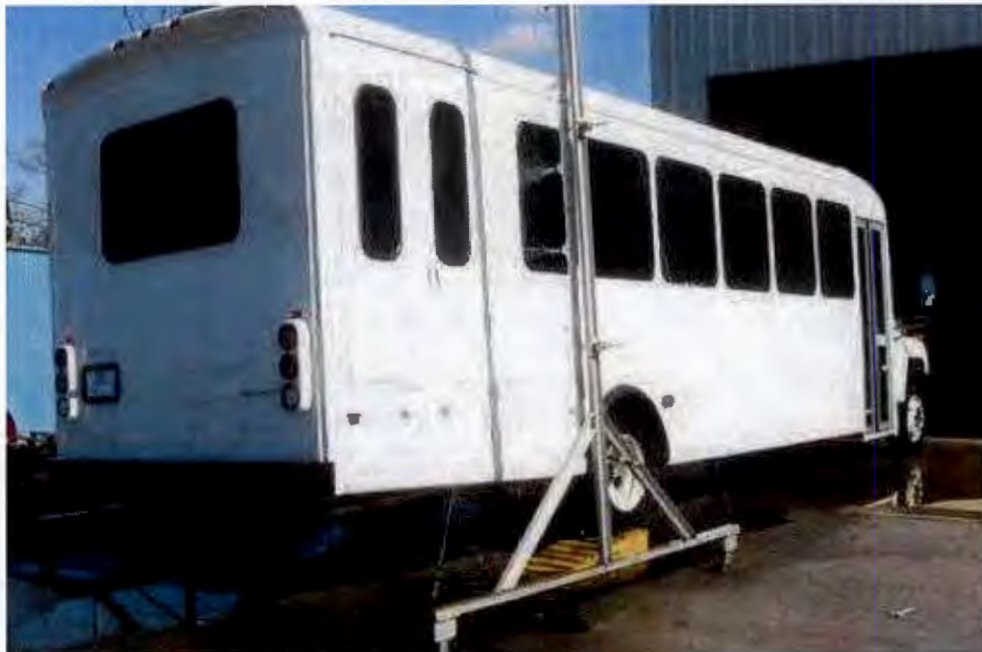
**RIGHT REAR WHEEL SIX INCHES HIGHER**

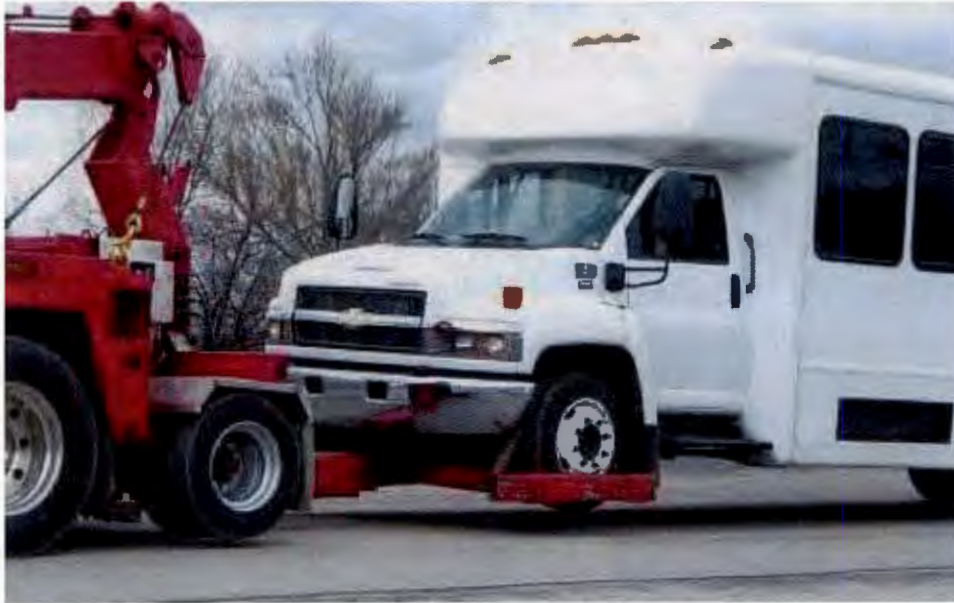
**TOWING INTERFACE**

The bus was towed using a heavy-duty wrecker. The towing interface was accomplished by incorporating a hydraulic under lift. A front lift tow was performed. Rear towing is not recommended. No problems, deformation, or damage was noted during testing.

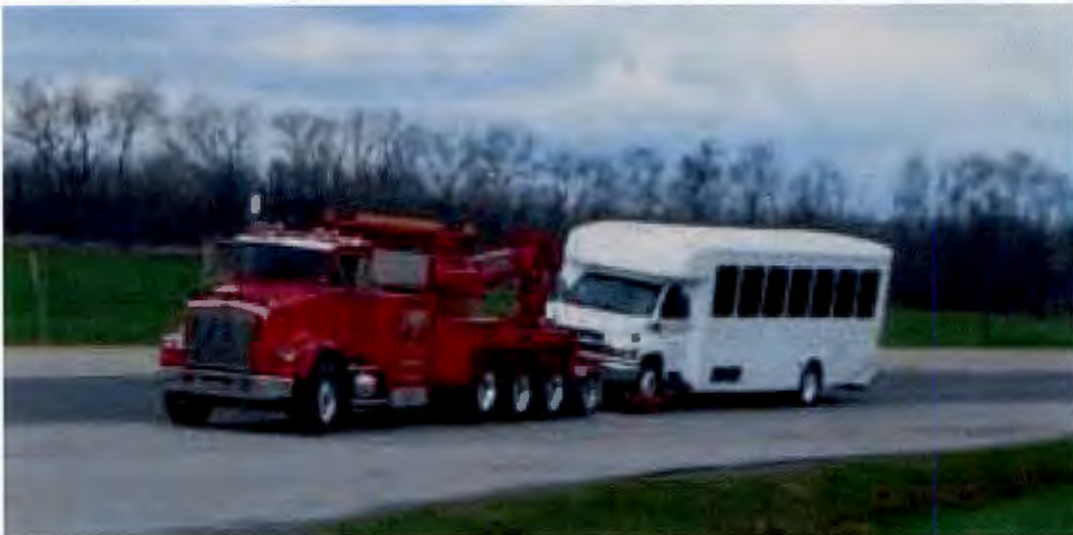
**TEST BUS IN TOW**

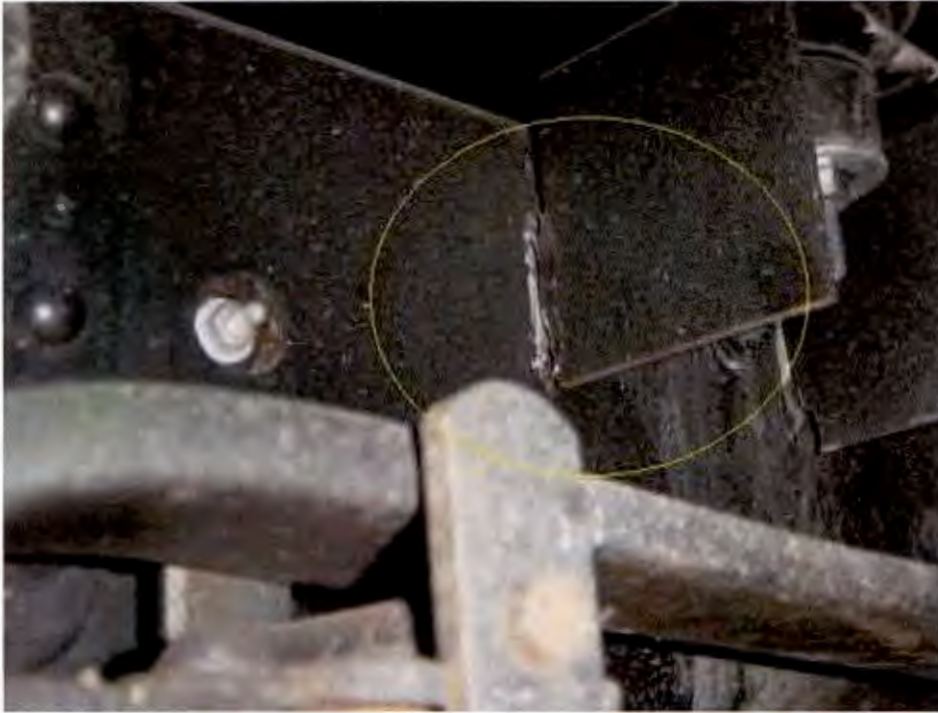
## CRACKED BODY TO FRAME MOUNT (719 TEST MILES)

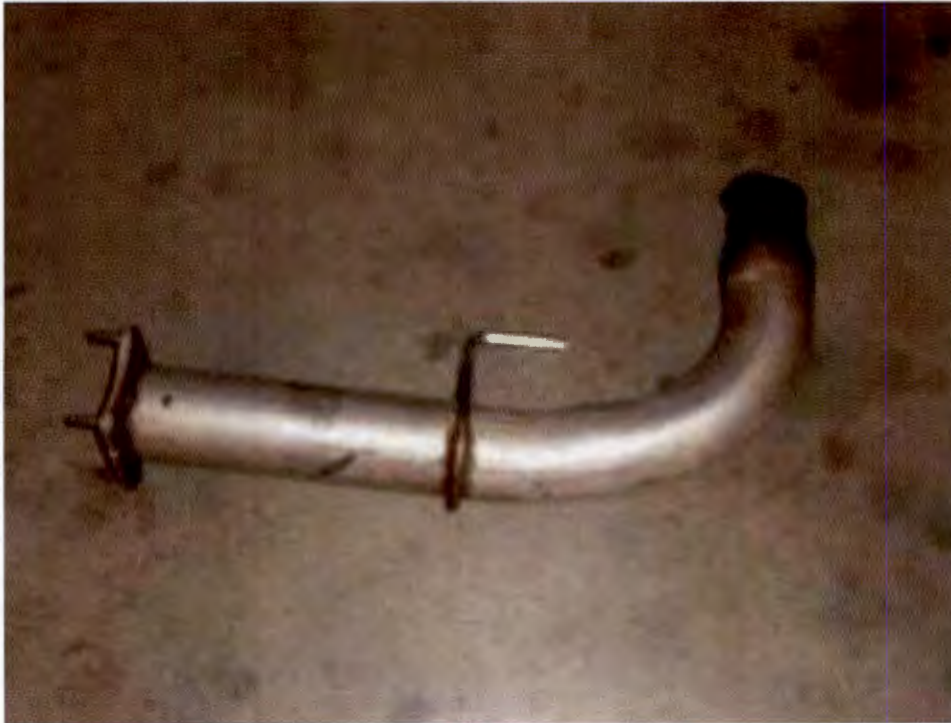
**FLANGE CRACKED ON EXHAUST DOWN PIPE  
(1,642 TEST MILES)**

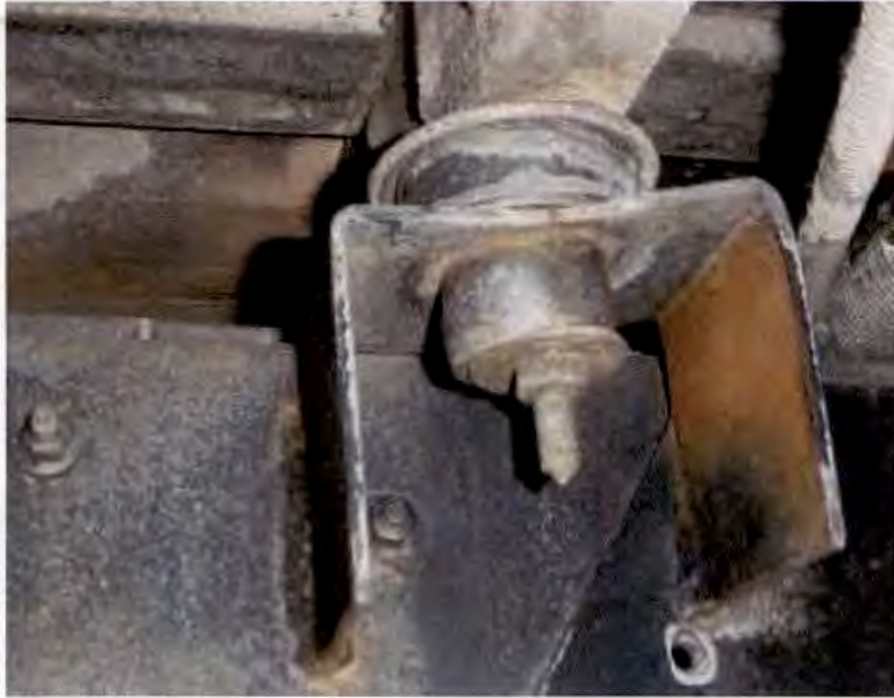
**BROKEN BODY TO FRAME BRACKETS  
(4,045 TEST MILES)**

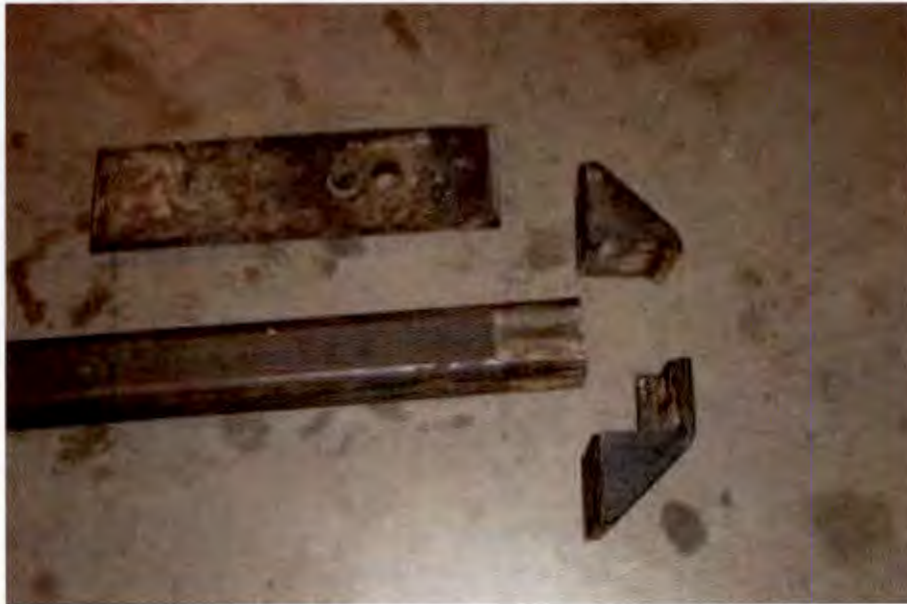
**BROKEN LEFT FRONT STABILIZER BAR BRACKET  
(4,045 TEST MILES)**

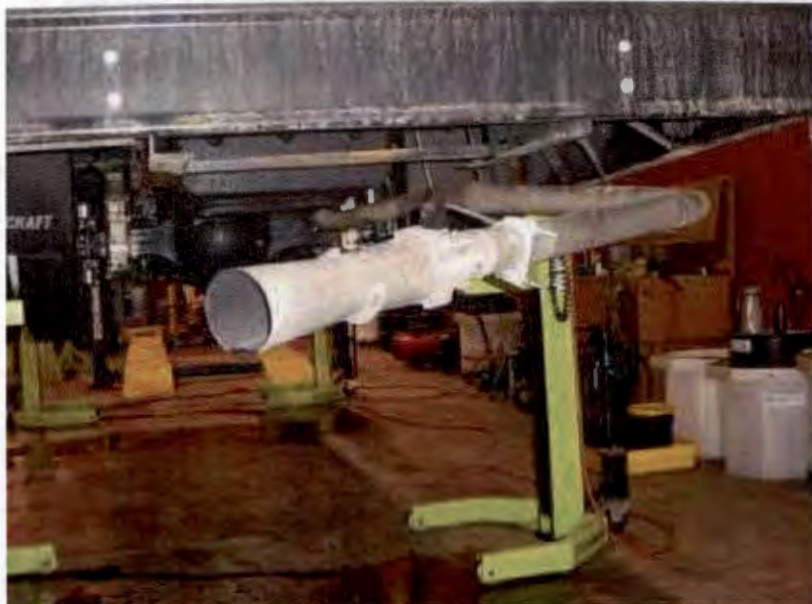
**BROKEN TAILPIPE HANGER  
(6,715 TEST MILES)**

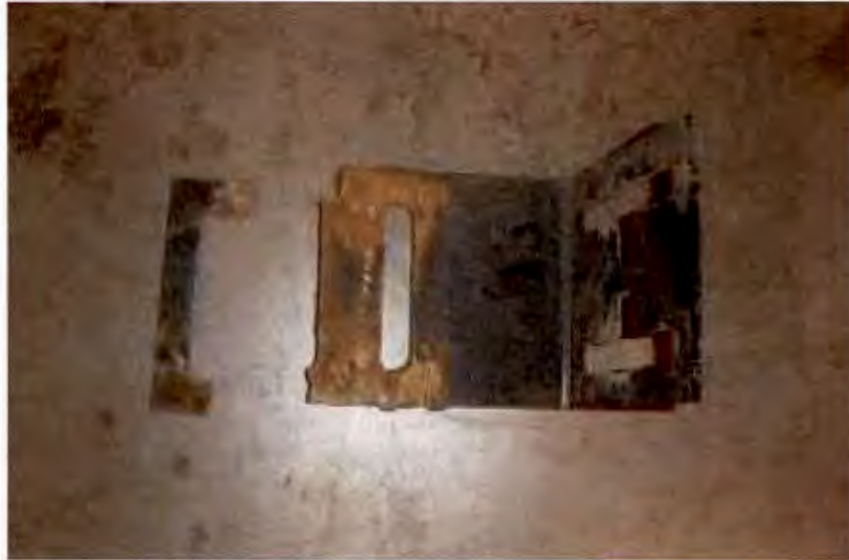
**FAILED BUMPER MOUNTING BRACKET  
(6,940 TEST MILES)**

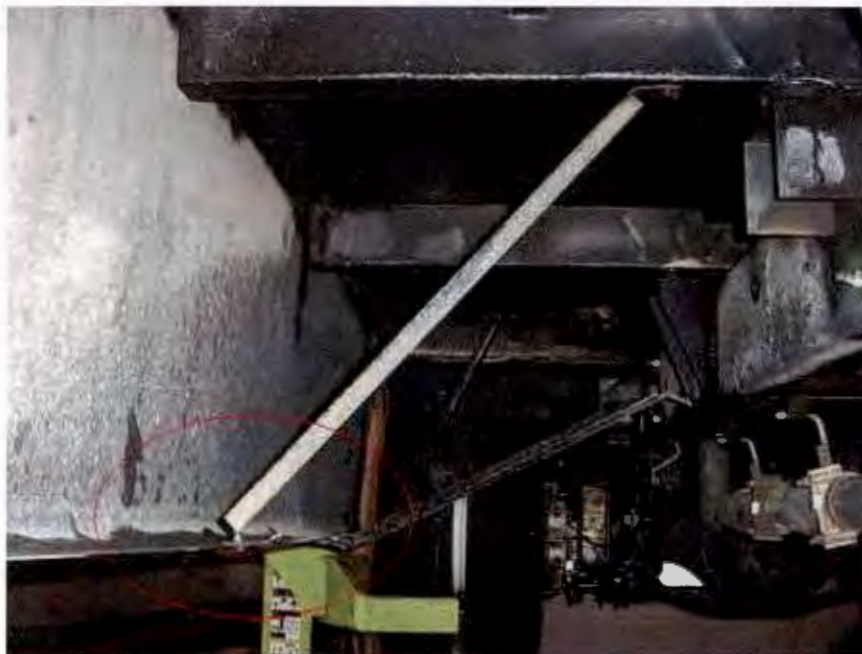
**BROKEN BODY PANEL SUPPORT  
(9,347 TEST MILES)**

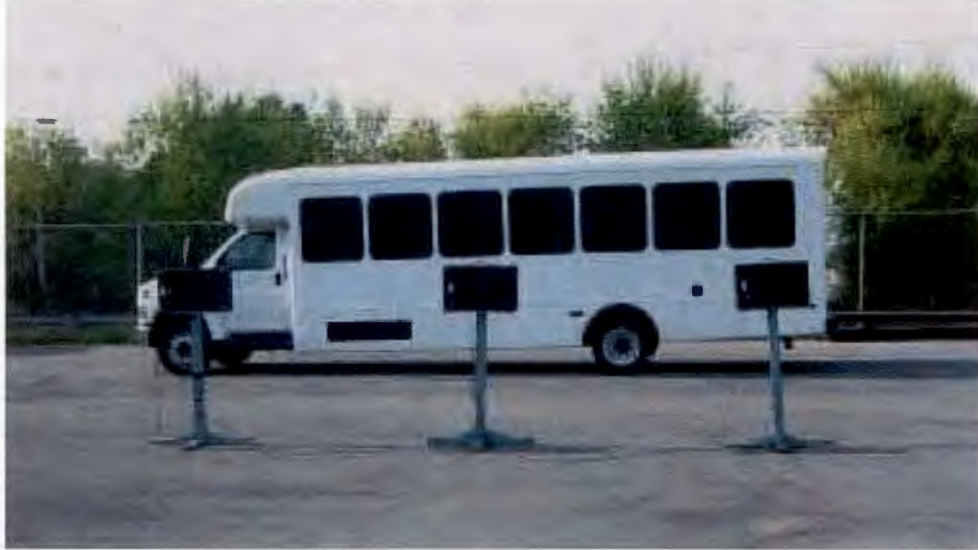
**TEST BUS SET-UP FOR 80 dB(A)  
INTERIOR NOISE TEST**

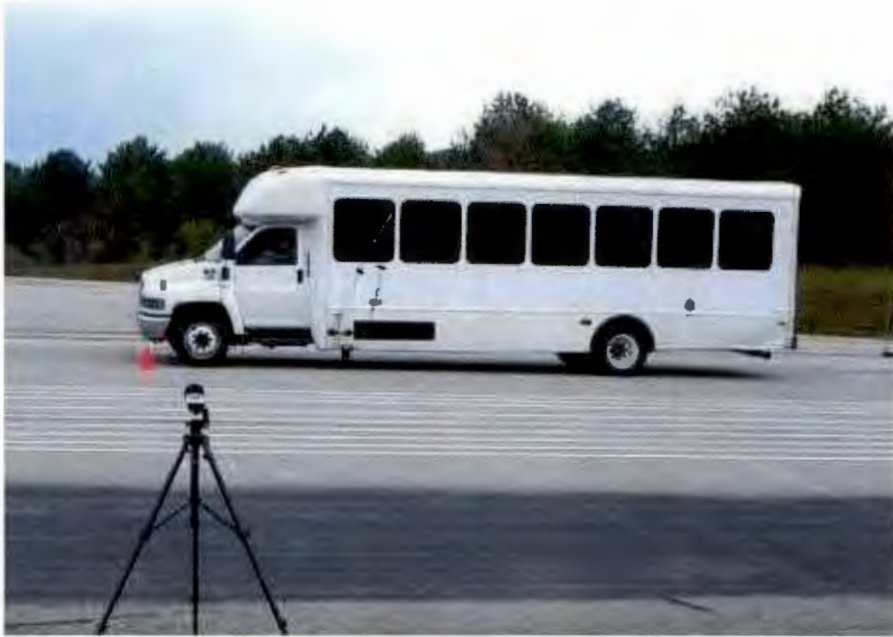
**TEST BUS UNDERGOING  
EXTERIOR NOISE TESTING**
