**AGENDA ITEM  
ST. JOHNS COUNTY BOARD OF COUNTY COMMISSIONERS**

**SUBJECT OR TITLE: Study of Summer Haven River and Surrounding Areas and Study of Summer House Erosion Findings, including potential FEMA Category B emergency protective measures.**

**RESOLUTION OF THE BOARD OF COUNTY COMMISSIONERS  
OF ST. JOHNS COUNTY, FLORIDA, RECOGNIZING AND  
APPROPRIATING A U.S. DEPARTMENT OF HOMELAND  
SECURITY FEMA GRANT AND A STATE OF FLORIDA  
DIVISION OF EMERGENCY MANAGEMENT GRANT WITHIN  
THE FISCAL YEAR 2024 GENERAL FUND.**

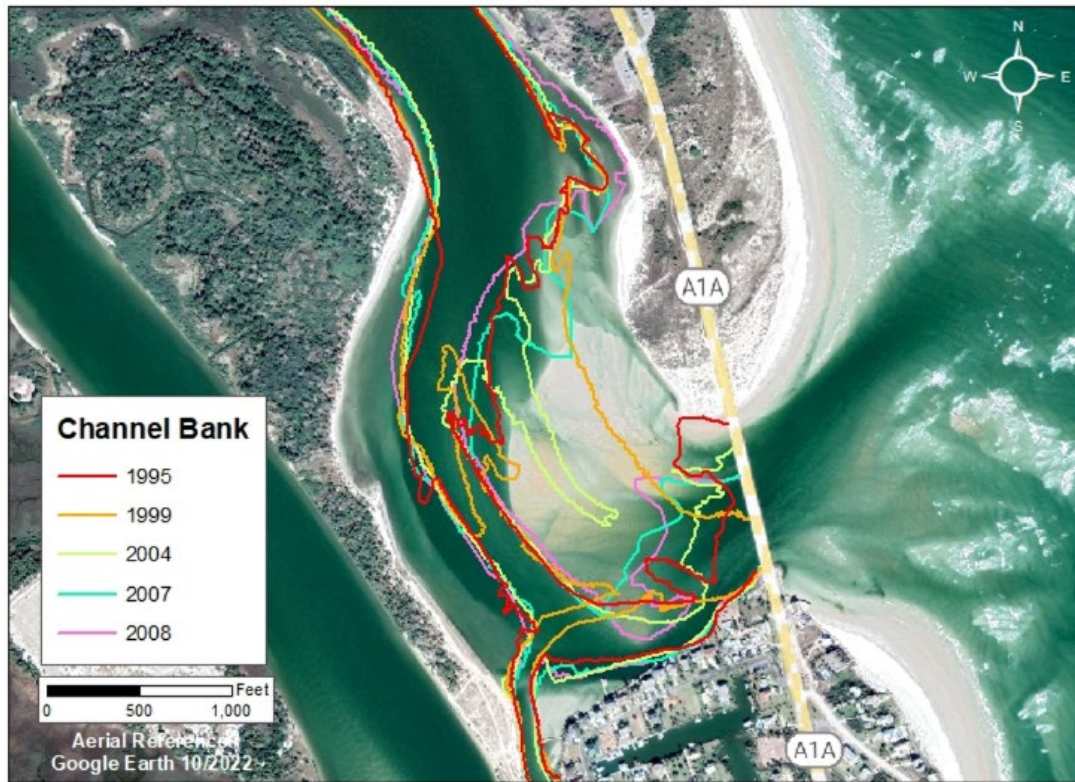
Figure 4.12 Matanzas Inlet Primary Channel Positions from 1995–2008

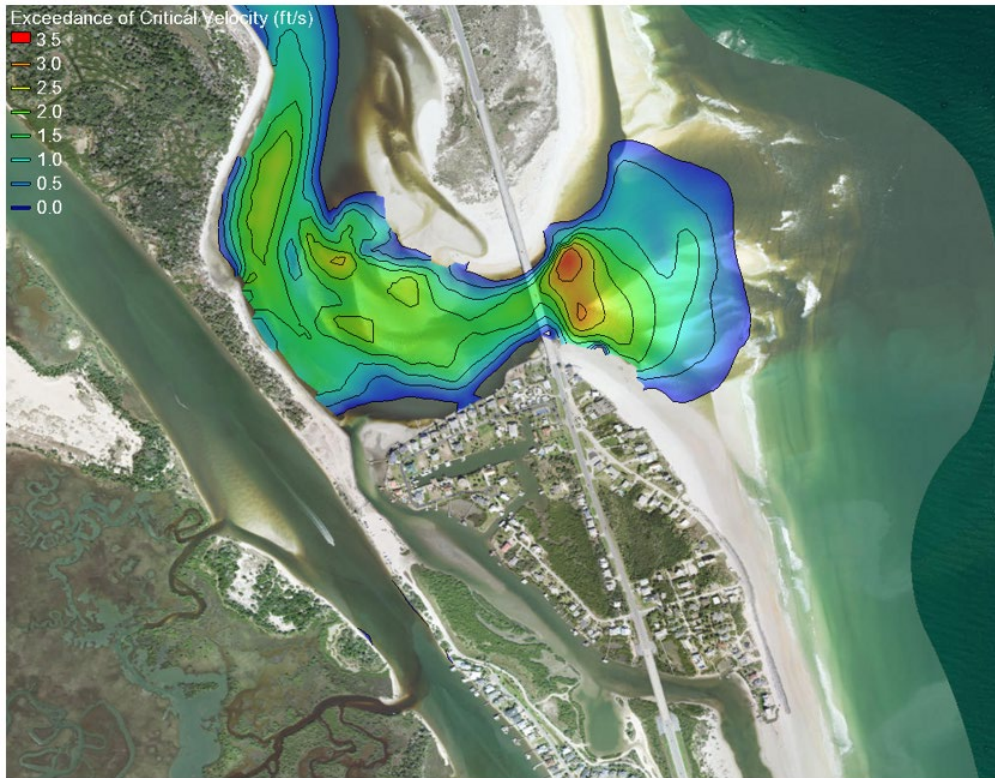
Figure 4.29 Exceedance of Critical Velocity at Peak Flood Flow – Existing Conditions

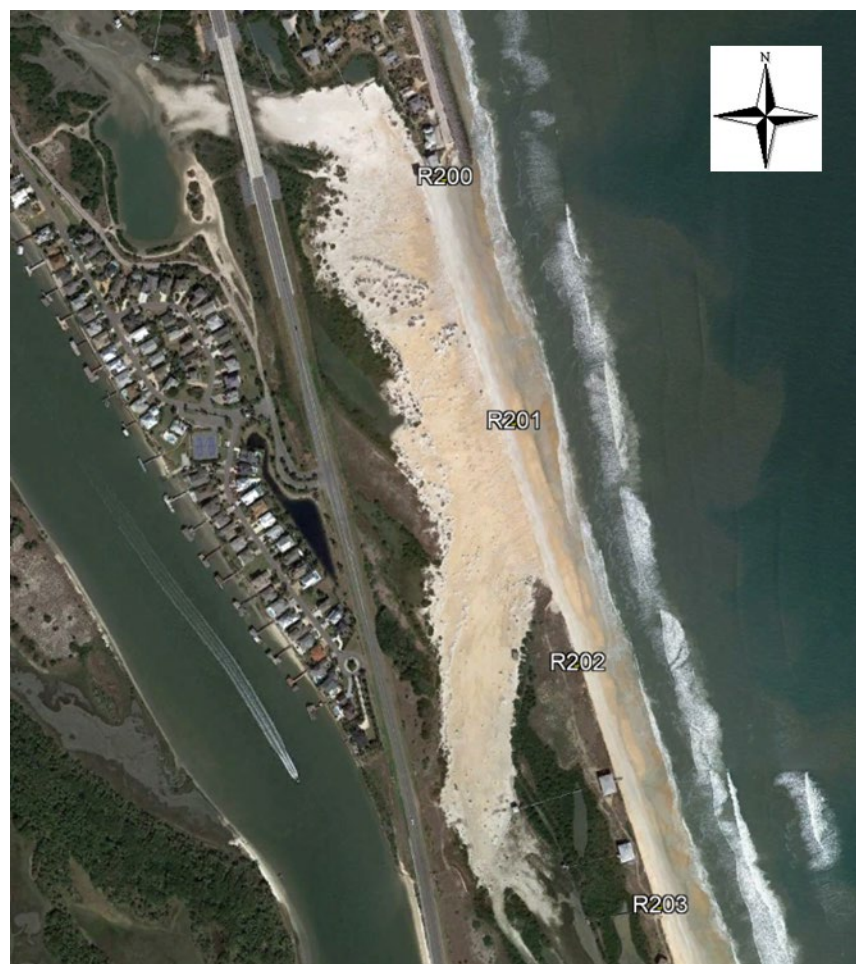
Figure 5.10 Conditions Approximately Eight Years after the T.S. Fay (2008) Breach

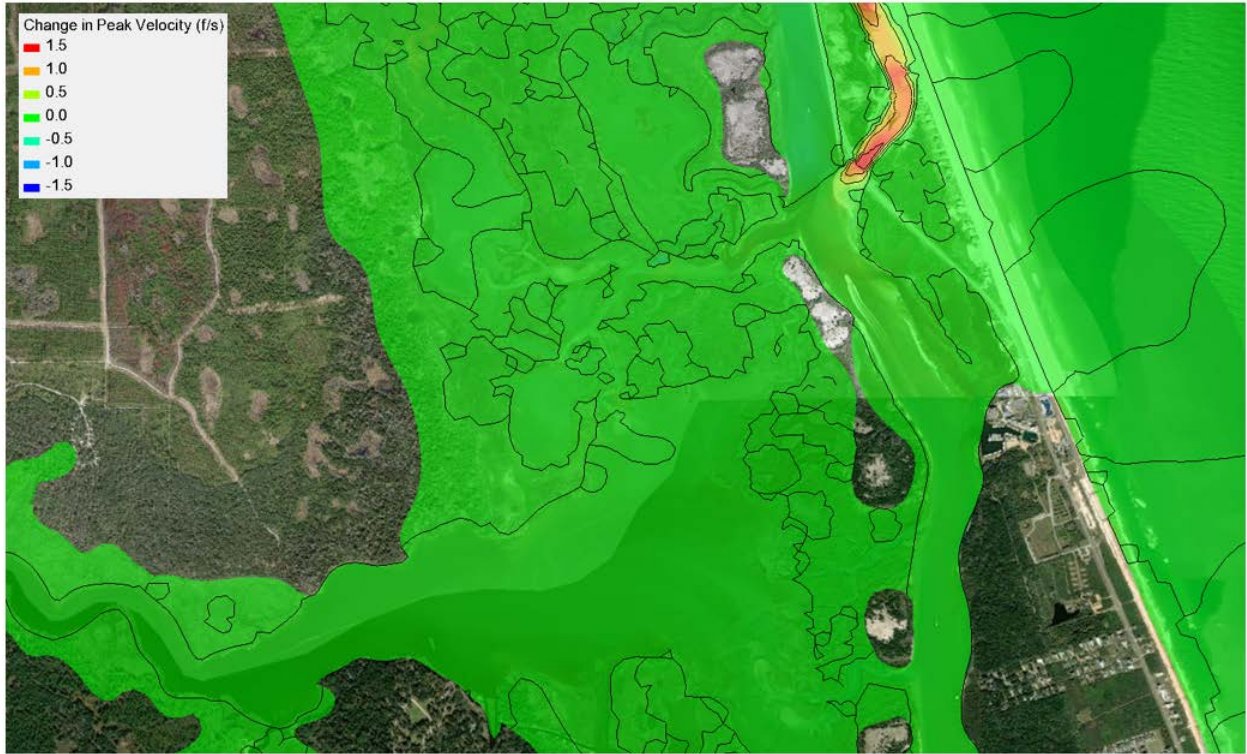
Figure 1.42 Change in Velocity within Inlet at Peak Ebb Flow – Scenario 2 vs. Existing Conditions

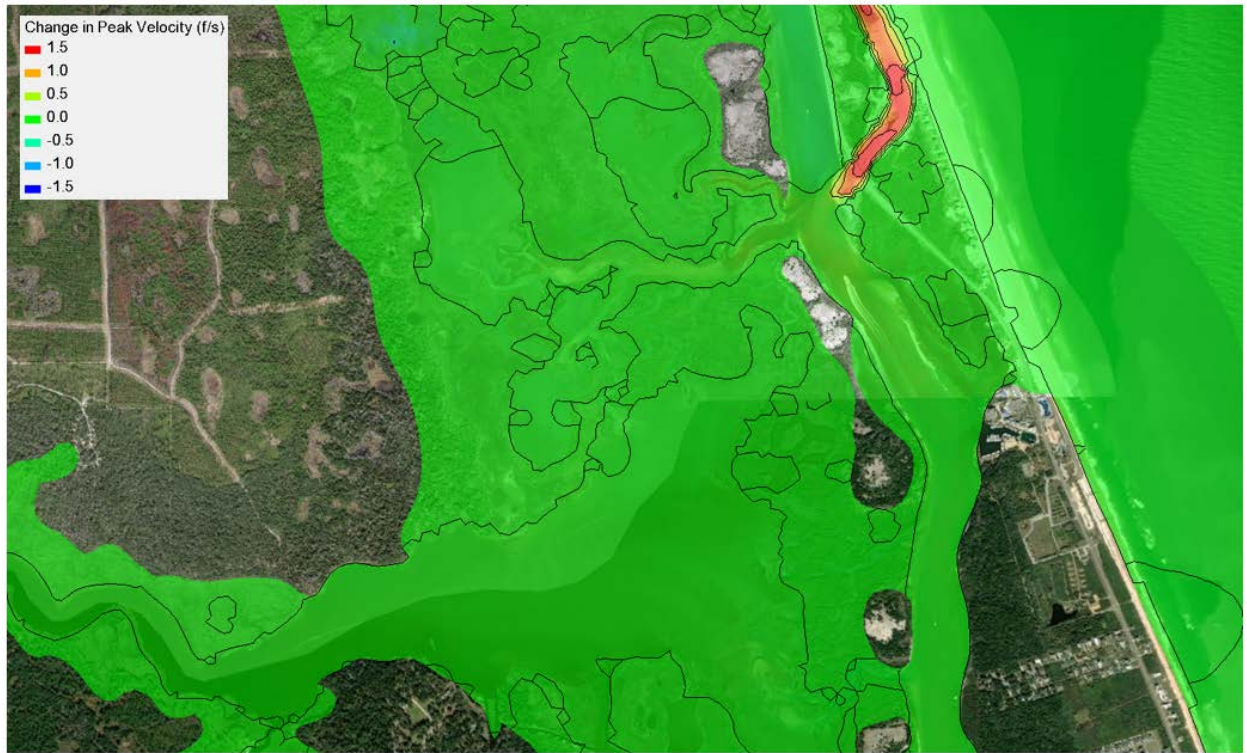
Figure 1.43 Change in Velocity within Inlet at Peak Flood Flow – Scenario 2 vs. Existing Conditions

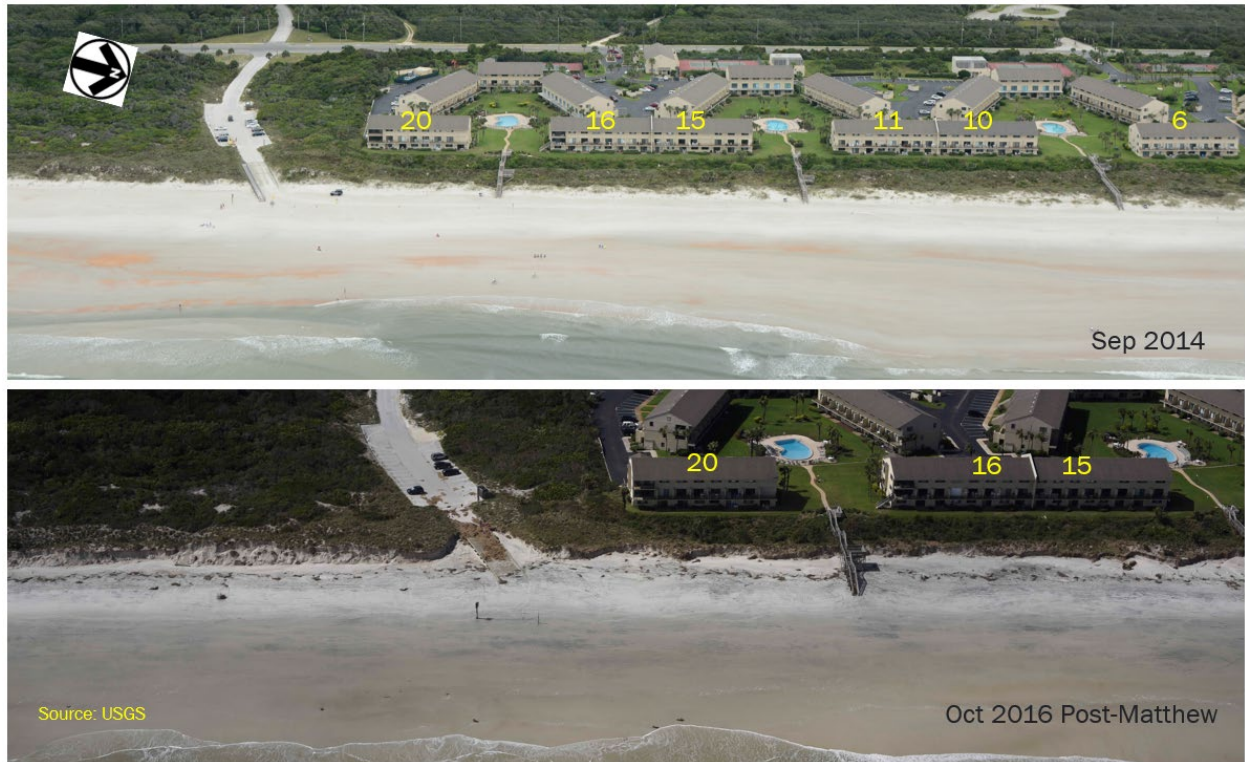
Figure 2.6 Comparison of Pre- and Post-Matthew Conditions near South End of Summerhouse

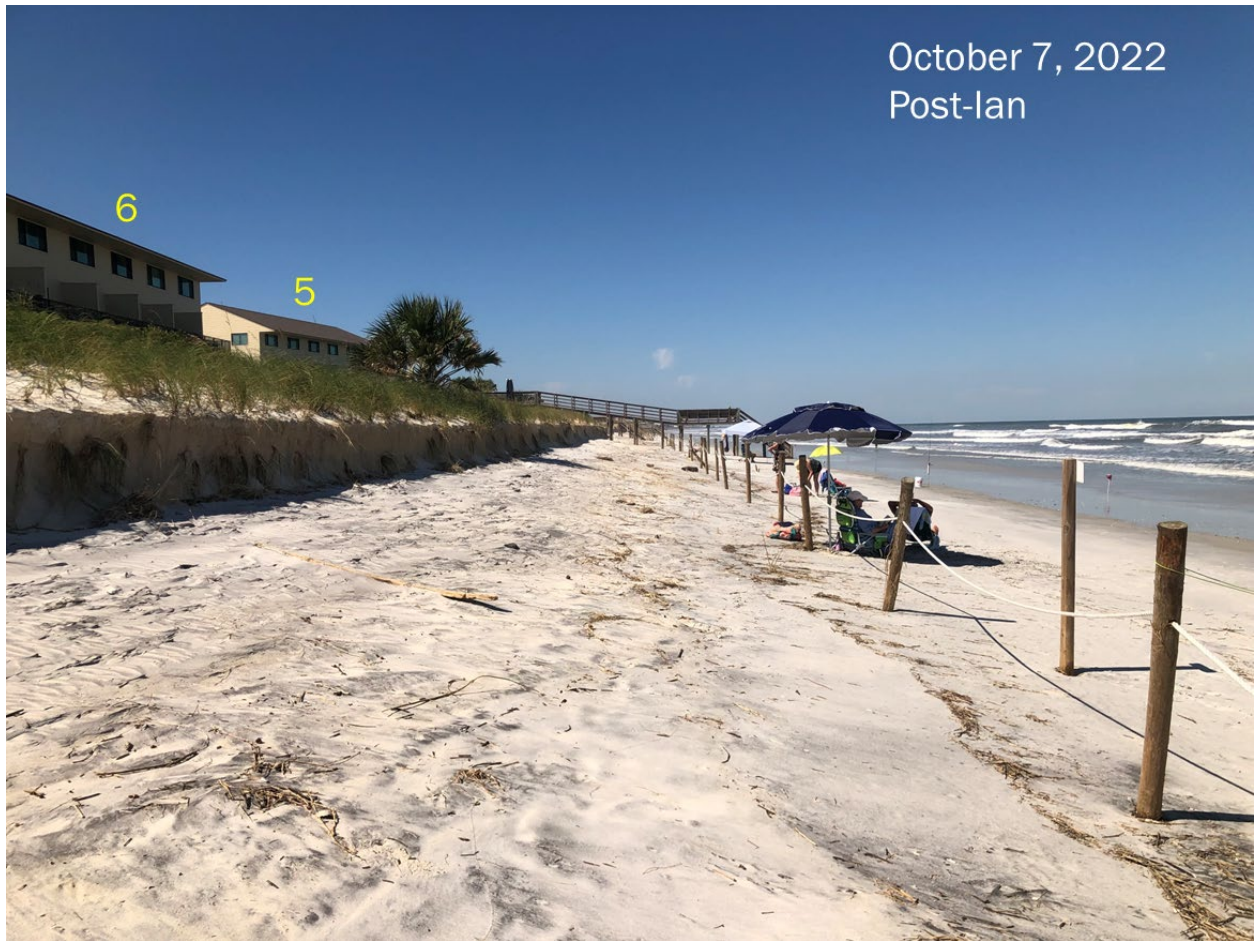
Figure 2.11 Post-Hurricane Ian Conditions near Buildings 5 and 6 (Looking North)

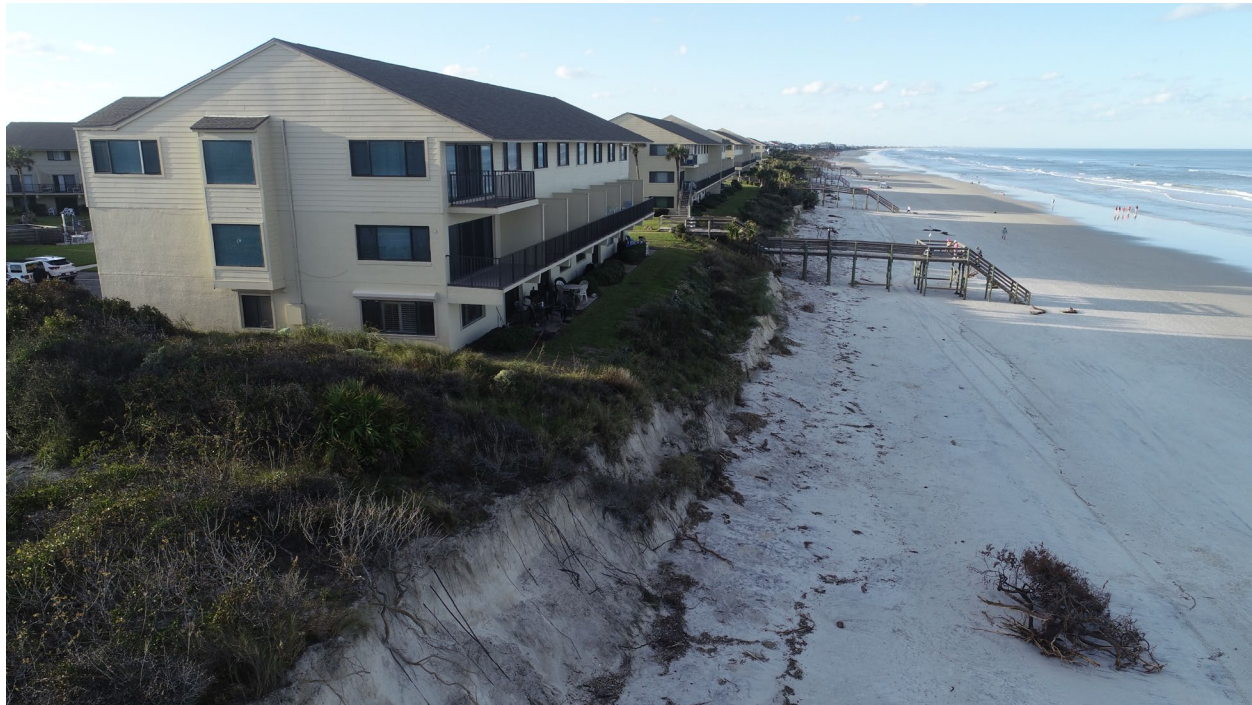
Figure 2.12 Post-Hurricane Nicole Conditions near Building 20 (Looking North) (source: Summerhouse)

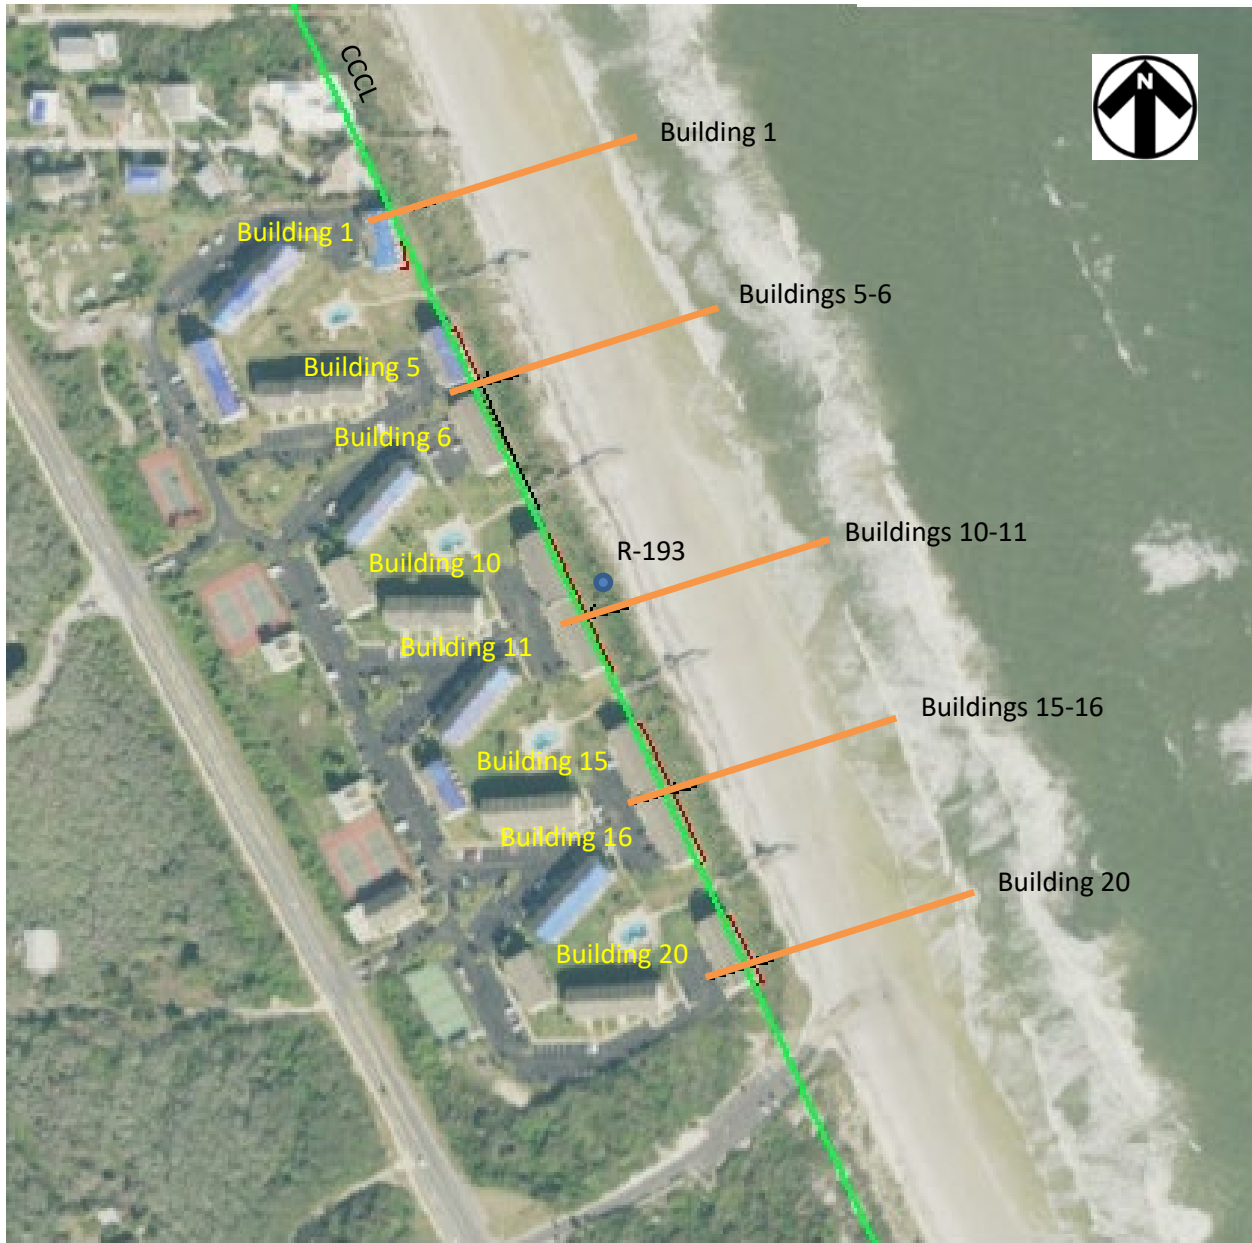
Figure 5.2 Pre-Storm Input Profile Locations
